NEL / REPORT 1281

FOULING ON A DEEP-ANCHORED SUBMARINE HULL

I. E. Davies and E. G. Barham • Research and Development • 12 April 1965

U. S. NAVY ELECTRONICS LABORATORY, SAN DIEGO, CALIFORNIA 92152 • A BUREAU OF SHIPS LABORATORY

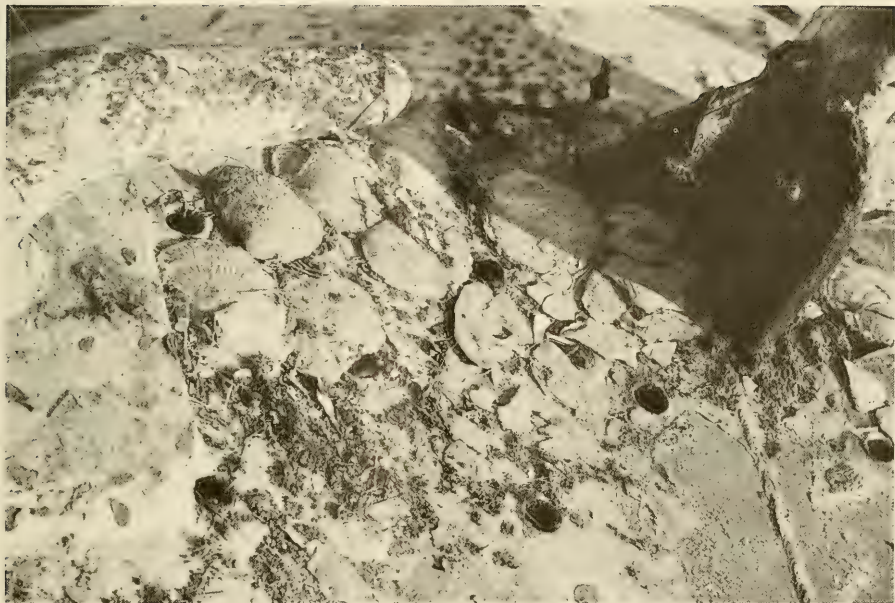
The False Jingle, *Pododesmus macroschisma* (fig. 2E), was the most prevalent organism associated with this zone. Hundreds of these shells littered the top deck. Many had been dislodged and left only scars or chordate-shaped byssus attachment remnants (figs. 2I, 3, 4). By observing the littered shells and scars made by the jingles on the deck and superstructure, it is estimated that at least 50 percent of the upper zone was covered by these animals (figs. 3, 4). The shells ranged in size from one to 4 inches in diameter with an average of approximately $2\frac{1}{2}$ inches. One upper valve of the rock scallop, *Hinnites multi-rugosus* (fig. 2C), was found on deck, and the shell was free of fouling, which is unusual for this species. Under the deck grating, on the deck supports, and on the railings, were several tests of large Serpulid tube worms, probably *Laeospira*. Clusters of small, parchment-shelled tube worms, tentatively identified as *Phyllochaetopterus prolifica*, were common in similar situations.

Figure 3. Shells of false jingles litter deck. Byssus attachment plates at left mark scars of dislodged valves.

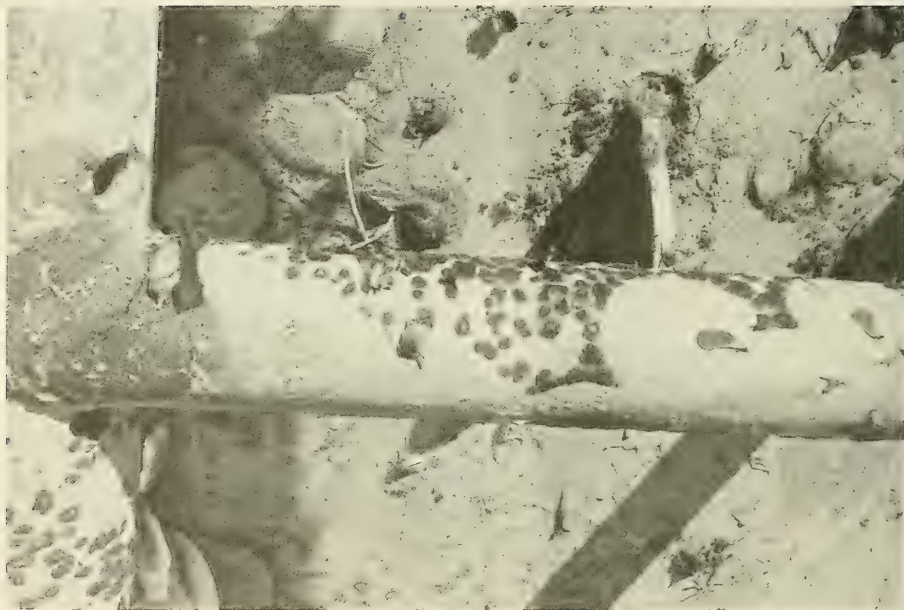
(fig. 2J), were interspersed among these barnacles and in other scattered locations (fig. 4). These ranged in size from $\frac{1}{4}$ to $\frac{3}{4}$ of an inch in diameter. Several large anemonies were attached to the sides. Their dehydrated condition made identification difficult, but they were probably a species of *Metridium* (fig. 4). Also present on the sides were dried colonies of small anemonies that appear similar to *Corynactis* sp. (fig. 4).

Figure 4. Jingle shells, solitary coral (upper center), and date mussel (lower center) on upper deck. Dried sea anemones (probably *Metridium* sp. and *Corynactis* sp.) and jingle scars cover the rails.

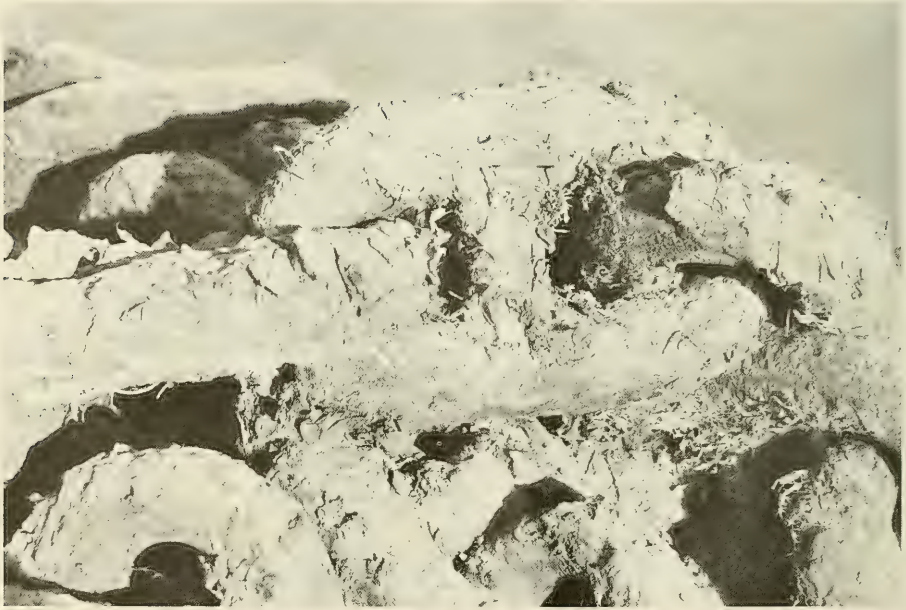
Portions of the tackle used in the deep mooring of the hull, consisting of a pile of $1\frac{1}{4}$ -inch chain (fig. 6) and some heavy polypropylene line (fig. 7) were also available for inspection. The chain was almost entirely covered with a foliaceous red algae. One large jingle, *Pododesmus macroschisma* was observed. Also present were colonies of the small tube worms, *Phyllochaetopterus prolifica*. A loose scab of rust, perhaps $\frac{1}{16}$ -inch thick, covered the links.

Figure 6. Red algae, tube worms, and bryozoans cover mooring chain links.

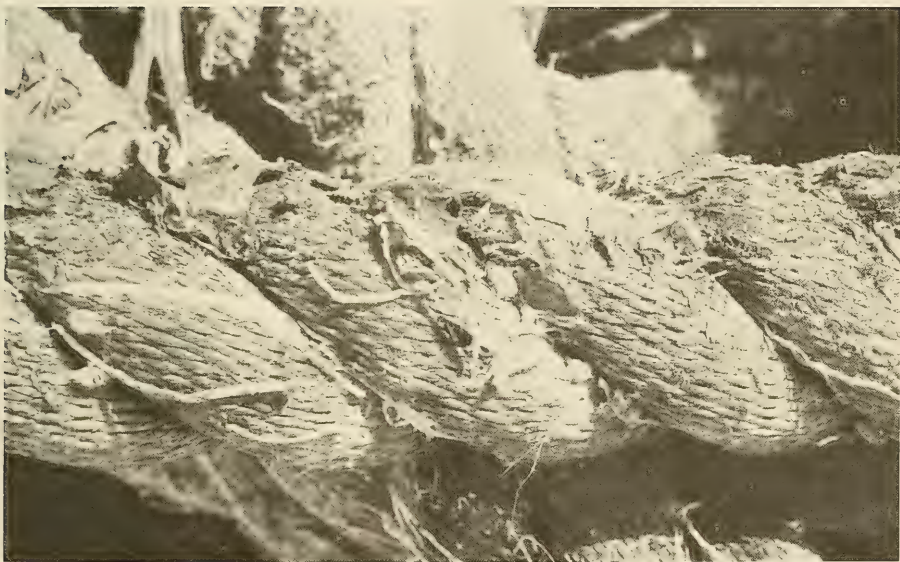
The line, which seemed to be in excellent condition externally was also fouled by red algae, but not as heavily as the chain. The tube worms, *P. prolifica*, present on the line seem to have taken hold in the creases of the lays. This is, in fact, where most of the fouling had settled. Many small horse mussels, *M. fornicatus*, were also found in the lays of the line (fig. 7). Scattered colonies of unidentified bryozoans and the base plates of barnacles were observed. There was no evidence of marine borers on the line. With the exception of the algae, the line was more heavily fouled than the chain.

Figure 7. Polypropylene line with numerous tube worms and small horse mussels concentrated along lays. A light fouling of red algae is also present.
